# West Wight Coastal Flood and Erosion Risk Management Strategy

## Appendix A - Defence Condition Review

November 2016

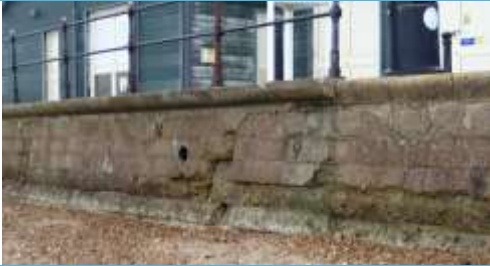
Defence Description	IW Unit	Policy Unit	Length (m)/ Crest Height (mODN)	Photo from AECOM Site Visit	Assessed by	Condition Grade	Residual Life (years)
Concrete block masonry wall	56/010	PU1A.3	211/ unknown

Capita / AECOM	Grade 3	15
					IWC	Grade 3	10 to 15
Rock groynes	56/011	PU1A.3	n/a

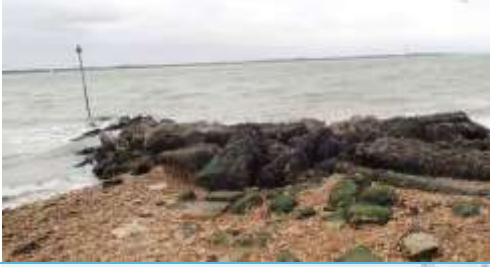
Capita / AECOM	Grade 3/4	15
					IWC	Grade 3	10 to 15
Concrete block masonry wall	56/015	PU1A.3	140/ 2.4

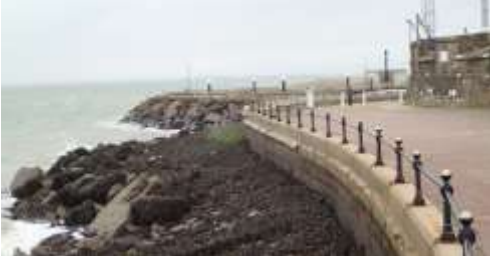
Capita / AECOM	Grade 3	15
					IWC	Grade 3	10 to 15
